Replacement SSB Must Be Configured for the TV

Failure to configure the SSB can result in no picture, the picture being severely shifted on the screen, and some features not functioning.

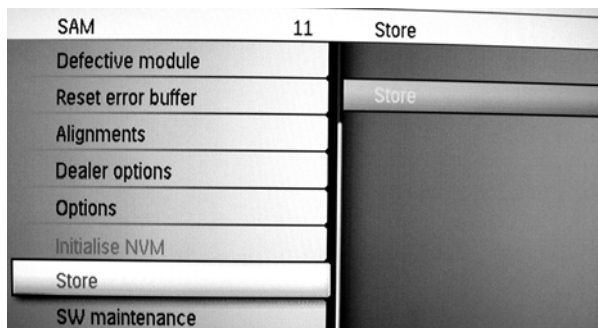
6. Cursor back to the SAM main menu and select STORE. Cursor right, then press OK to store the changes. STORE COMPLETE or a similar message should be displayed. Turn the TV off then back on to activate the changes. SSB configuration is complete.
